TEMIC Status

K. Einsweiler, LBNL

Reverse Engineering of FE-D Die

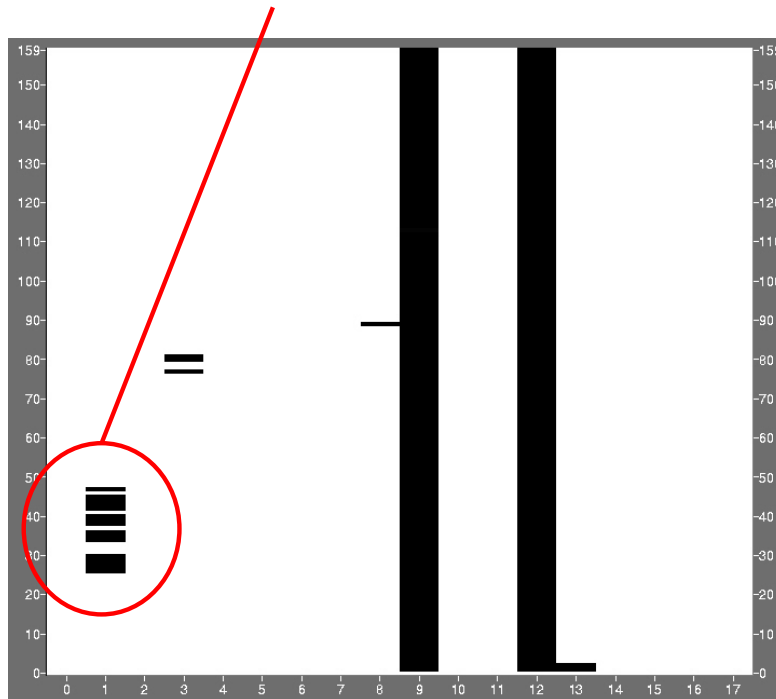
FIRST CHIP: FED #6:

THIS CHIP HAS A CLUSTER OF BAD PIXELS IN COLUMN 1:

PIXEL ID	20MHz		10MHz		5MHz	
	READOUT	FREEZE	READOUT	FREEZE	READOUT	FREEZE
26 (BAD)	OK	OK	OK	OK	DEAD	OSCIL
27 (BAD)	ROW-0	OSCIL	DEAD	OSCIL	DEAD	OSCIL
28 (BAD)	OK	OK	EXCESS	OSCIL	DEAD	OSCIL
29 (BAD)	OK	OK	ROW-0	OSCIL	DEAD	OSCIL
30 (BAD)	DEAD	OSCIL	DEAD	OSCIL	DEAD	OSCIL
31 (BAD)	OK	OK	OK	OK	DEAD	OSCIL
32 (BAD)	OK	OK	OK	OK	DEAD	OSCIL
33 (GOOD)	OK	OK	OK	OK	OK	OK
34 (BAD)	OK	OK	DEAD	OSCIL	DEAD	OSCIL
35 (BAD)	DEAD	OSCIL	DEAD	OSCIL	DEAD	OSCIL
36 (BAD)	ROW-0	OSCIL	DEAD	OSCIL	DEAD	OSCIL
37 (BAD)	OK	OK	OK	OK	50%	OSCIL
38 (BAD)	DEAD	OSCIL	DEAD	OSCIL	DEAD	OSCIL
39 (BAD)	OK	OK	ROW-0	OSCIL	DEAD	OSCIL
40 (BAD)	OK	OK	ROW-0	OSCIL	DEAD	OSCIL
41 (GOOD)	OK	OK	OK	OK	OK	OK
42 (BAD)	OK	OK	ROW-0	OSCIL	DEAD	OSCIL
43 (BAD)	ROW-0	OSCIL	DEAD	OSCIL	DEAD	OSCIL
44 (BAD)	OK	OK	DEAD	OSCIL	DEAD	OSCIL
45 (BAD)	OK	OK	DEAD	OSCIL	DEAD	OSCIL
46 (GOOD)	OK	OK	OK	OK	OK	OK
47 (BAD)	EXCESS	OSCIL	DEAD	OSCIL	DEAD	OSCIL

- Digital scans gave a cluster of bad pixels, then individual probing was used to classify their behavior as a function of the column clock frequency.

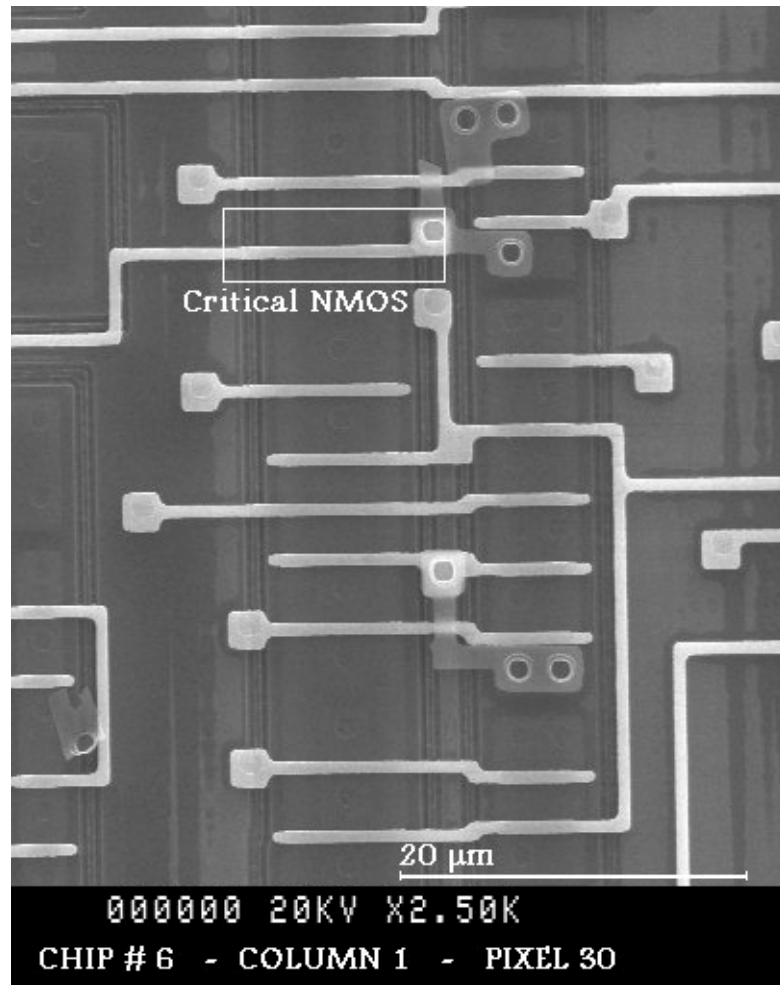
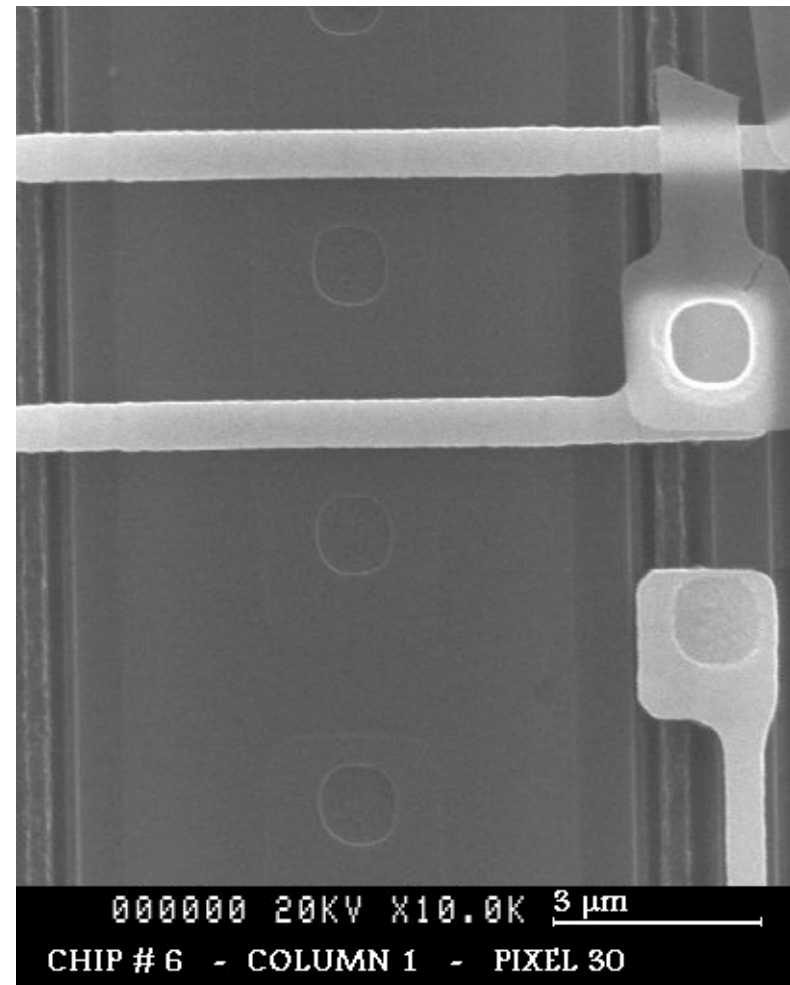
- TEMIC then reverse engineered (removed layers by chemical etch steps) to explore whether there were problems in the poly patterning step:

- Box surrounds gate of reset NMOS (leaky device). Figure on right shows expanded view of gate, and also nearby M1-poly contacts overlapping trenches.

- No sign of any problems in poly patterning.

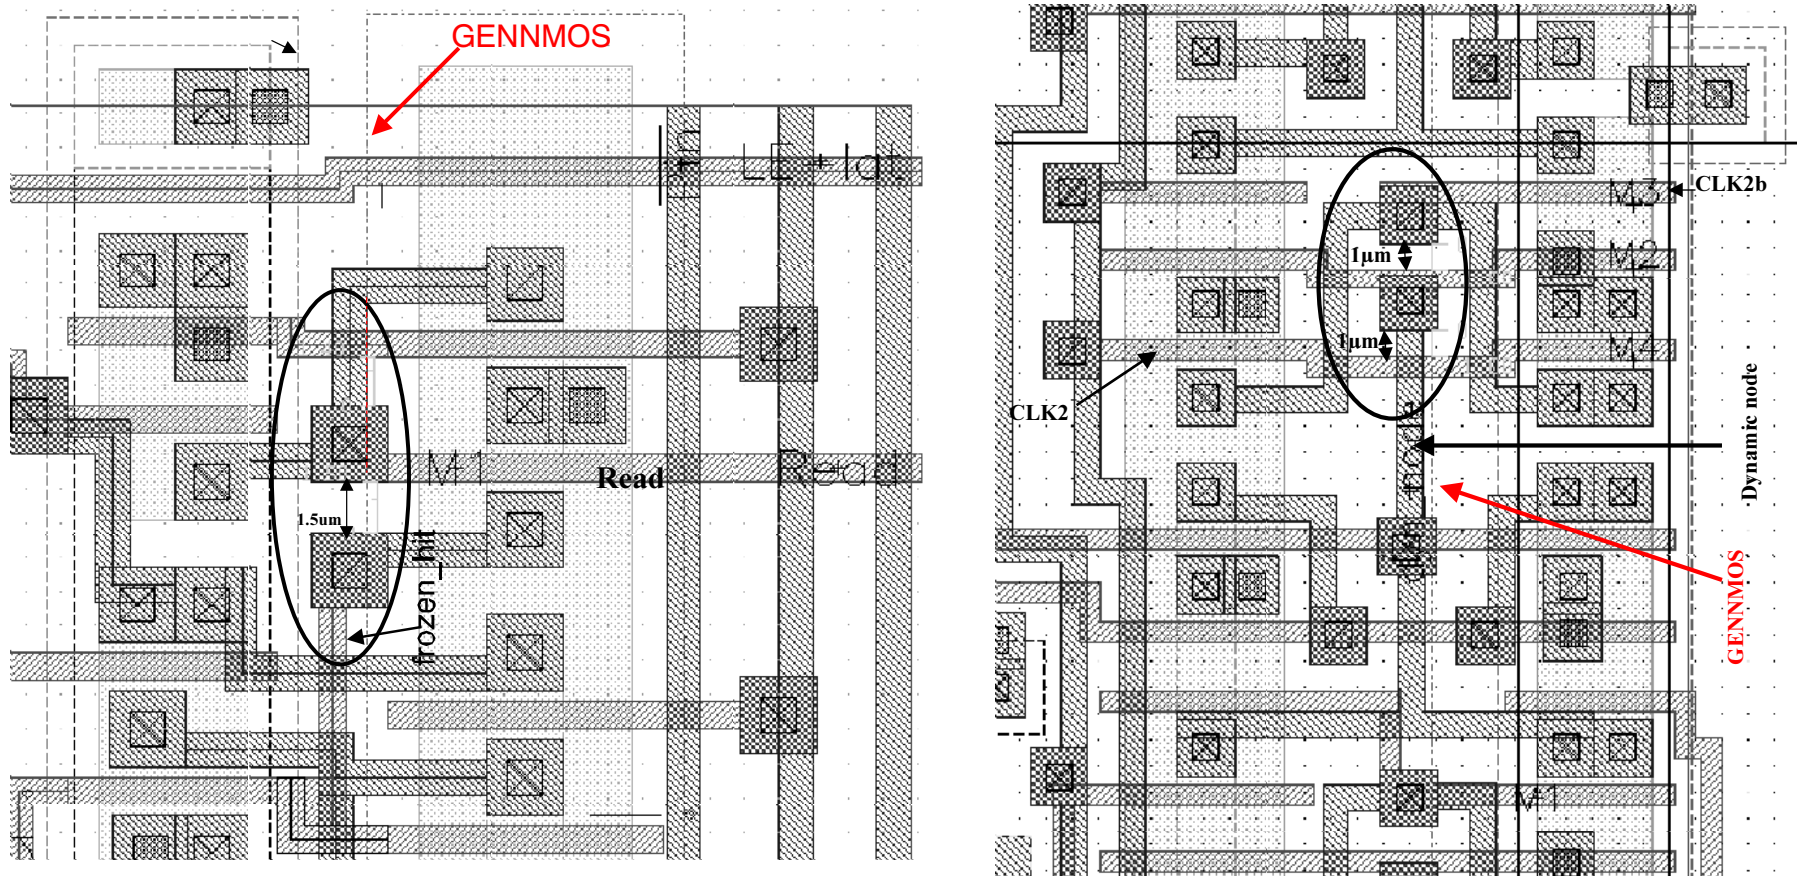
- After a detailed study, Eric concluded that in his opinion, the problem with traces and contacts over trenches could also be at the root of the FE-D problems. In particular, for the two low-yield logic blocks, he indicated the following:

- Left is the hit logic, with R between Read and FrozenHit, right is Pixel Register.

- After we examined the FE-D1 layout in more detail, it was clear that there was a strong correlation between layout features of this type, and dynamic nodes with/without problems.
- In particular, there is no such layout feature in the LE/TE RAM (where we see no evidence of defects, despite the fact there are 14 bits per pixel, compared to the one dynamic node in the hit logic), nor in the ff_edge FF in the hit logic, nor in the ff_edge FF in the EOC blocks.
- In addition, Mario has studied whether this type of problem could explain the mysterious “diode shift” which we observe in all devices. He believes it could be consistent, since even large resistances could cause diode shifts, whereas small resistances are required to actually cause the “row 0” failure we see:

- We will continue to discuss these issues with relevant experts.
- Mario has tried to respect Eric's proposed "extended DRC" to reduce probability of problems with poly etching, although the details of this picture do not completely match our results.

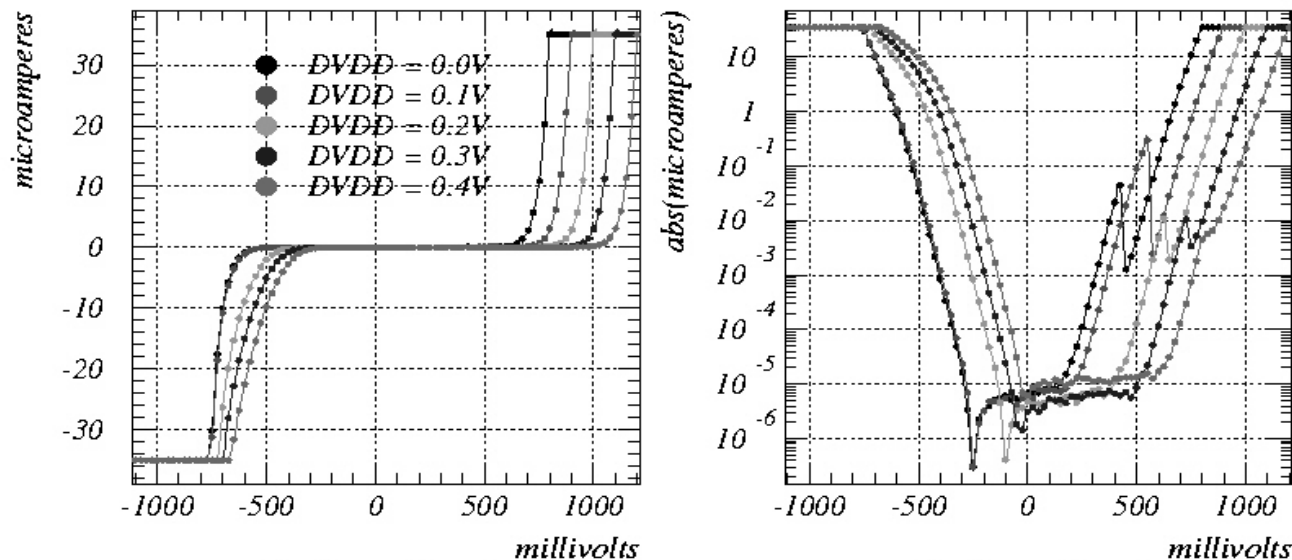
FE-D 1 Column 12 Row 157

- Diode being turned on for negative V_{Drain} is from drain implant to well, connected to DGND. It should not move when DVDD is varied.

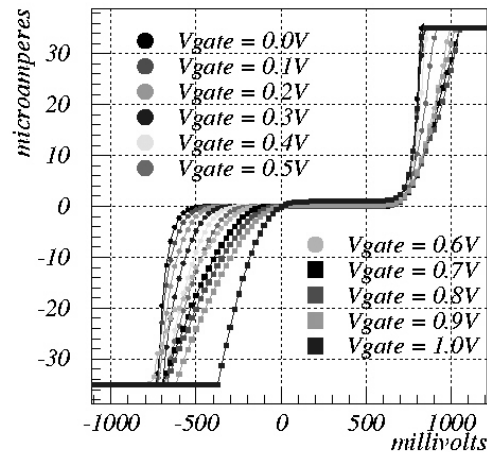
Idrain vs Vdrain for Good Pixel (3,0)

- On the other hand, this model makes detailed predictions for failures, including that the hit logic failure should appear as a resistance between the FrozenHit and the Read node (the drain and the gate of the leaky NMOS). In our detailed measurements from LBL (made at Peter's suggestion), we can rule this out:

- If the resistance was between drain and gate, then in this series of 2D scans, the curves would not always pass through zero current when the drain voltage was zero. Instead, they would shift so that zero current occurred when the drain-gate voltage was zero.
